ABT Burner Issues

Discussion with Staff

October 26, 2005

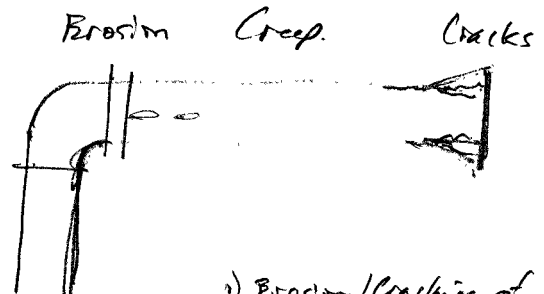
PI I Nozzles : tips

- 1) Erosion/Cracking of tip.
- 2) Creep (Stage II) of nozzle
- 3) Erosion of nozzle
